SAS Superstructure

Daily Diary Report by Bid Item

Diary #: 425 Const Calendar Day: 779 Date: 27-Oct-2011 Thursday

04-0120F4
04-SF-80-13.2/13.9
Self-Anchored
Suspension Bridge

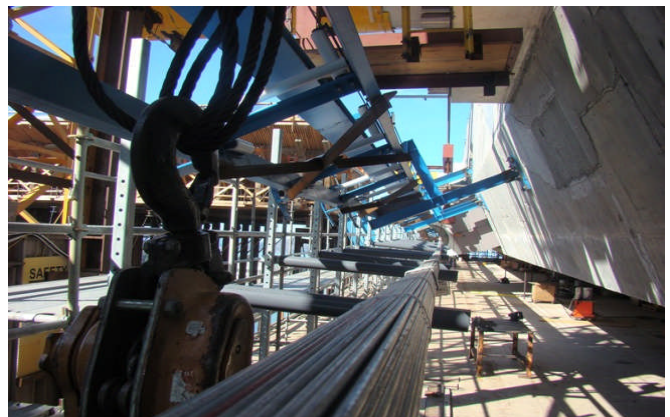
Practice cable strand seen from the jacking saddle to the W2W west deviation saddle.

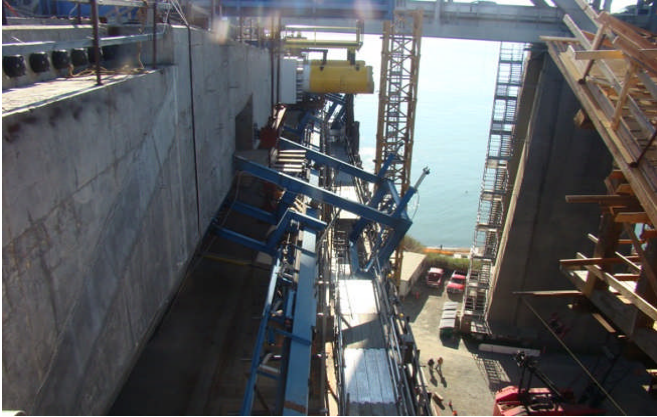
View from the 2nd resection point used to survey the low side face of the W2E west deviation saddle and the north side face of the jacking saddle.

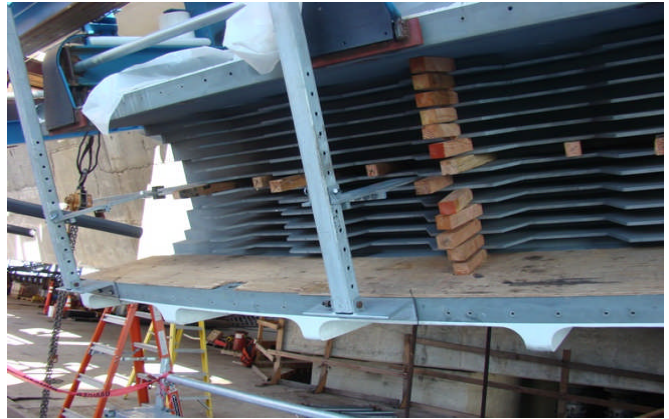
Completed practice cable strand formed/shaped at the jacking saddle placed into the saddle trough divider plates..

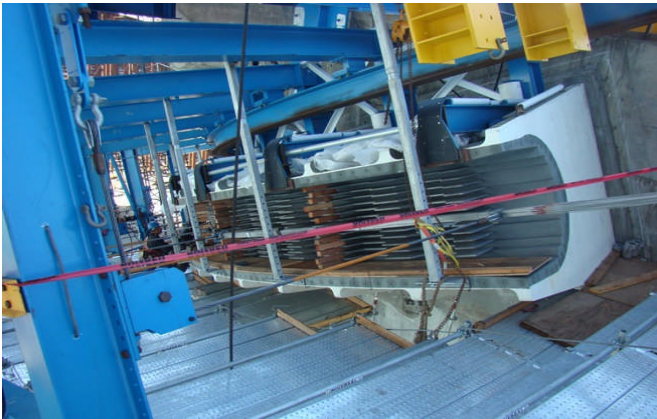
ABF ironworkers continuing to form/shape the practice cable strand at the W2E west deviation saddle prior to placing into the saddle trough dividers.

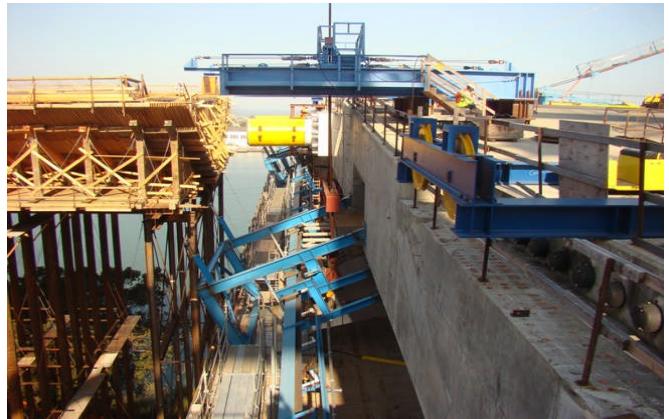
View from the 1st resection point used to survey the low side face of the W2W west deviation saddle and the south side face of the jacking saddle.
